BMW 5er-Reihe G31

Touring
from 03/2017

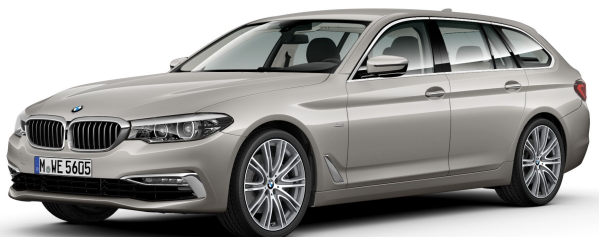
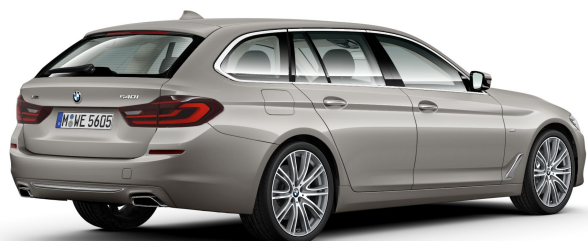
Airbag

Stored gas inflator

Seat belt pretensioner

SRS control unit

Pedestrian protection active system

Automatic rollover protection system

Gas strut / Preloaded spring

High strength zone

Zone requiring special attention

High voltage disconnect (cutting solution)

Battery low voltage 12V/48V ⁽¹⁾

Ultra capacitor, low voltage

Fuel tank

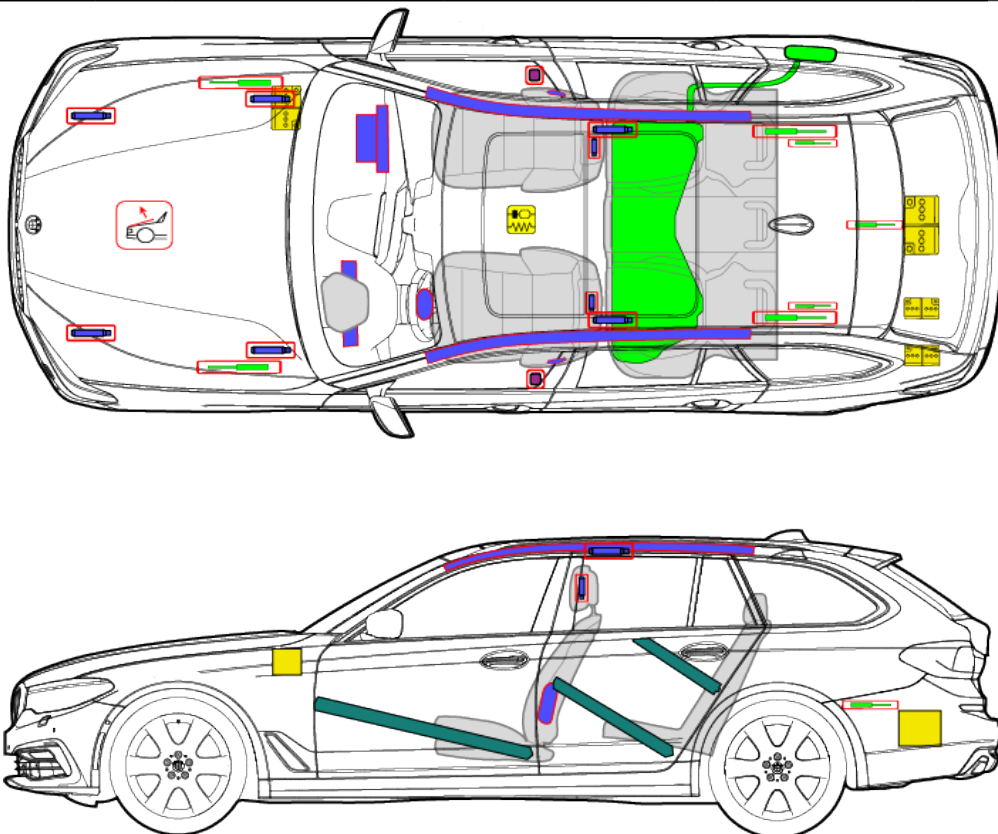
This overview shows the maximum range of equipment of the vehicle.
¹Switch off the ignition to avoid the risk of an electric arc when disconnecting.

Important: For more information see rescue manual.
